***2010 Addendum to***  
**2007 Angora Wildfire Hydrophobicity Field Monitoring Report**  
**Lake Tahoe Basin Management Unit**

December 2010

Authored by Sarah Howell, Hydrologist, Tim Tolley, Hydrologist,  
and Sue Norman, Hydrologist

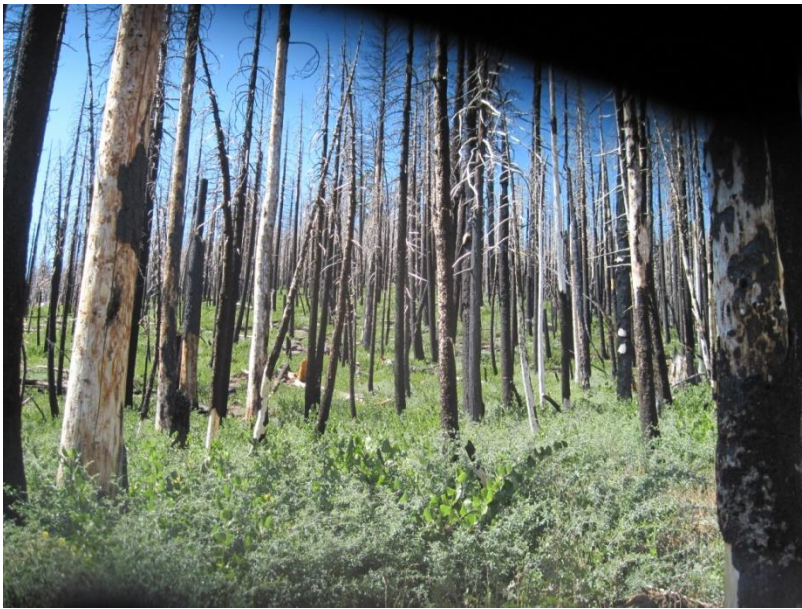
*July 2010 Visual Survey Traverse:* Vegetation cover and height has increased once again this year (Photo 1). In the high severity burn area, vegetation covers approximately 60-70% of the soil compared to 50% cover last year. There are more shrubs and brush than forbs, and shrubs are 1-2 feet tall. Trees have been planted, and the area around the trees has been scraped to bare soil in a 2-3 foot diameter circle. The trees are 6-15 inches tall. There are some patches where vegetative cover increases to about 80-90%. In the area above Lookout Point Circle, the trees show signs of high severity burn (no needles left), but vegetative cover increases to almost 100%. In this area, there are rushes, big lupine, columbine, snowberry, white thorn and other species. Some hydromulch is still intact and covers about 50% of the soil in some areas, but most areas have less than 50% hydromulch cover.

Photo 1: Vegetation in Angora burn area. Cover is approximately 80% in this area.

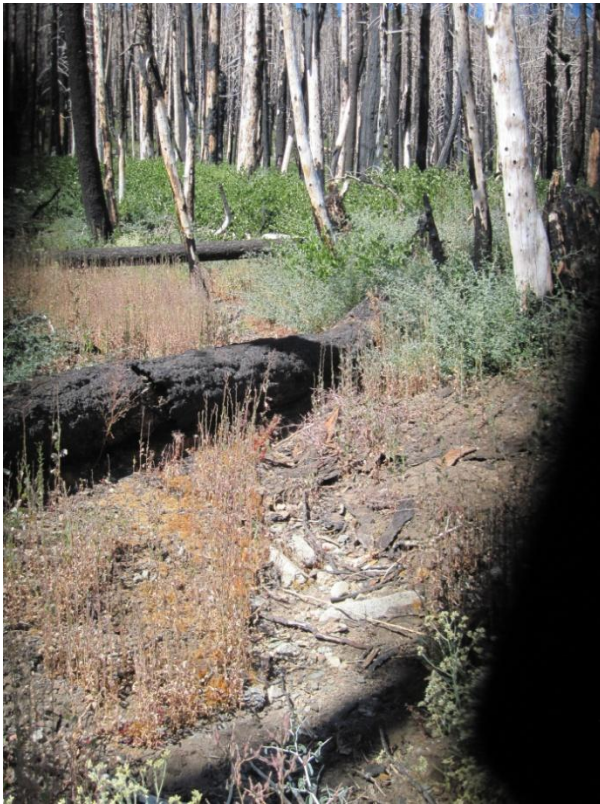
Some erosion features from overland flow were found again this year, but in a different location than previous years.. Multiple rills (about 10) were found during the July walking survey and are displayed on Figure 4. The aspect is north east facing in this area because it is on the side of a draw. The rills were approximately 6-10 inches wide and 6-12 inches deep, but almost all appear to be stabilizing (Photo 2). They have rounded banks and vegetation is filling them in. Pine needles and small branches have also deposited and accumulated in these features which have helped with stabilization. Most rills do not appear to have recently transported soil/sediment. The longest rill is approximately 100 feet long. This is the only area where we found erosion features during this walkthrough. The gully that was identified last year could not be relocated this year, probably due to the increase in vegetative cover.

Photo 2:. Large rill in Angora burn area observed during July visual survey. Forest litter and vegetation appears to be stabilizing the rill.

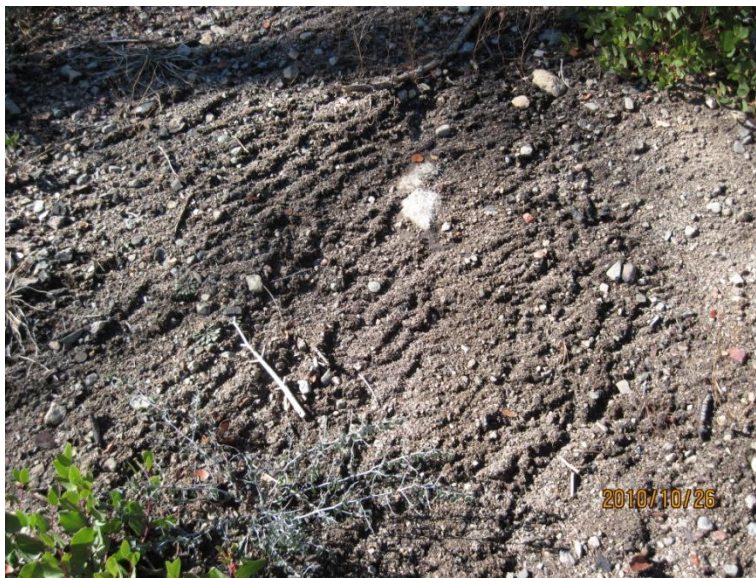
Along the upper portion of Angora ridge evidence of sheet erosion was essentially universal (Photo 3). Sheet erosion of sediment has been transported by the storm flow; however, evidence of significant concentrated flow in the form of large rills or gullies was mostly absent along the higher portion of the ridge. A few small and mostly discontinuous rills were observed along the upper half of the ridge (above approximately

Photo 3. Sheet erosion on upper slope of Angora Ridge observed during October visual survey (approximately 7,000 feet elevation).

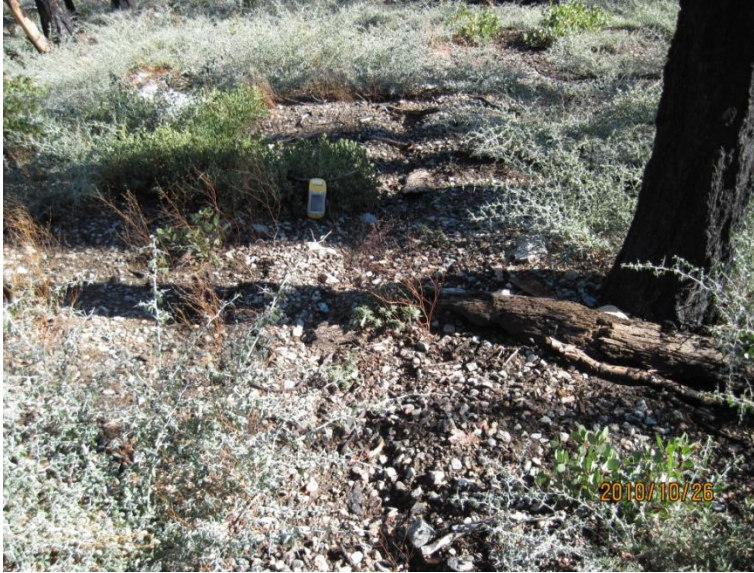
7,000 feet). The largest rills observed were approximately 1-2" deep, 6-8" wide, 50'+ long (Photo 4). Vegetation (mostly white thorn, manzanita, and huckleberry oak) in this area is quite thick, in the range of 30-70% coverage, with an overall average brush coverage estimated at approximately 50%. Much of the eroded sediment was caught by this brush.

Photo 4: Largest rill found during the October visual survey. Dimensions are 1-2" deep, 6-8" wide, 50'+ long.

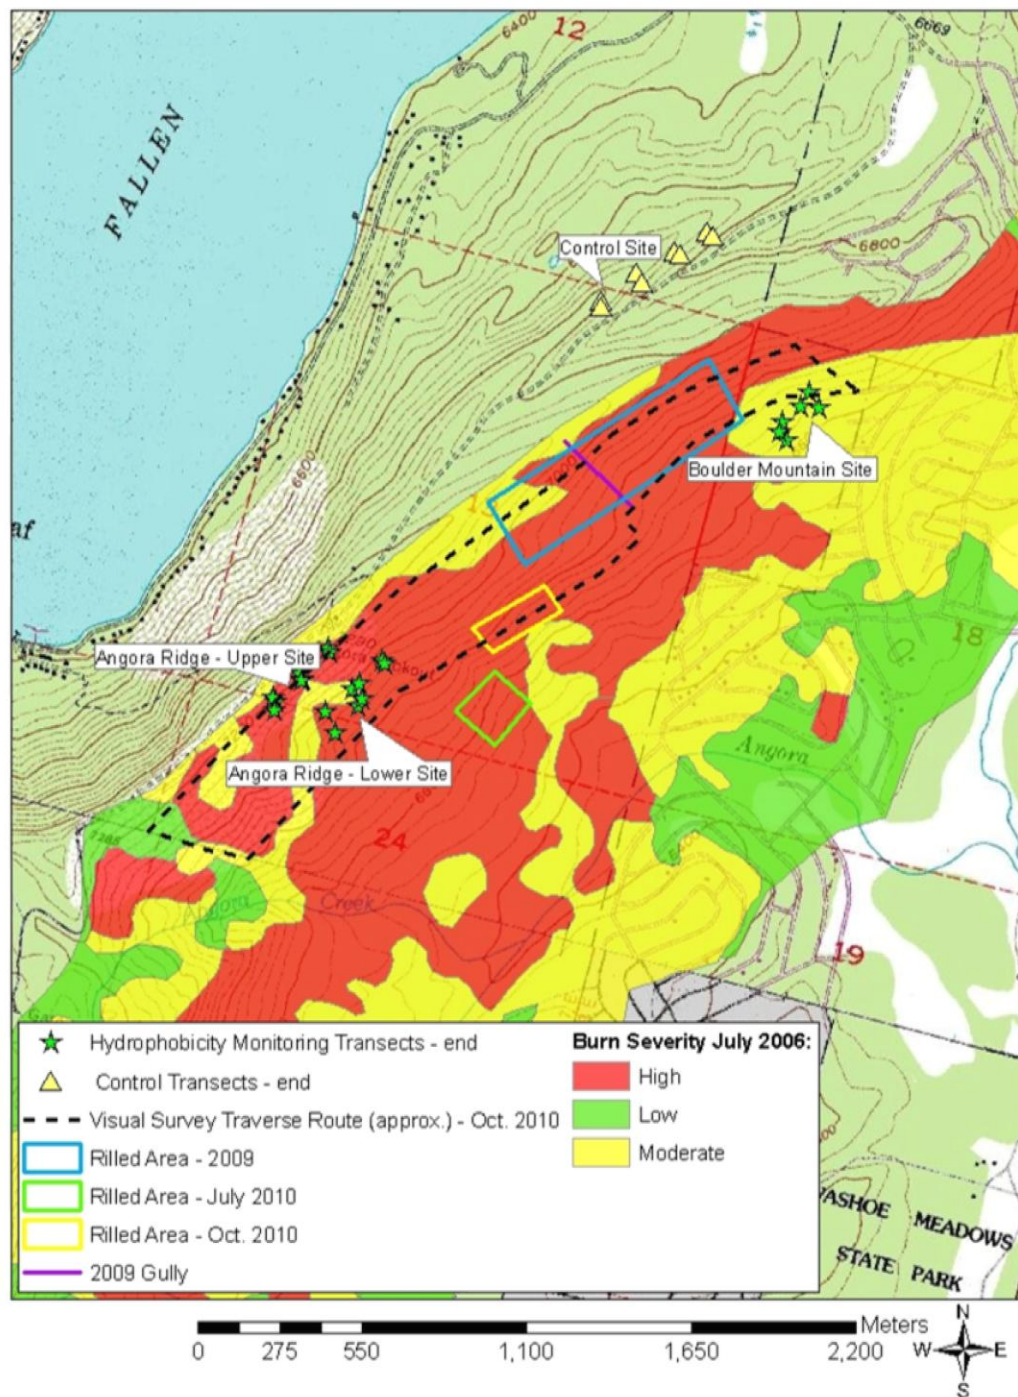
An area of more concentrated rilling was encountered at approximately 6,800 feet elevation the ridge at the location illustrated on Figure 2. The rilling here, although widespread, was fairly discontinuous. Average rill dimensions is estimated at 2-4" deep by 4-8 inches wide, and 10-20 feet in long. Spacing of rills in this area is estimated at 10-20 feet on average. Again, shrubs often interrupted the flow of sediment.

Figure 2. Map of the locations of erosion in the Angora burn area identified during 2009, July 2010, and October 2010 visual observation surveys. Hydrophobicity monitoring transects are also displayed.

Because hydrophobicity monitoring over the past four years has shown no significant change, and significant sediment delivery to stream channels no longer appears to be a major threat, we recommend that the frequency of monitoring (hydrophobicity and visual survey traverse) be reduced. Therefore hydrophobicity monitoring and visual surveys are scheduled to be repeated in the same year as the next planned aerial photography flight of the burn area, in 2013.
